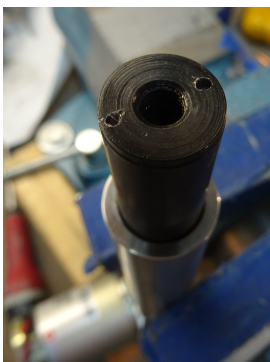
Vans wants you to drill a hole in the push extending arm of the flap motor. This is kind of freaky to do but not as difficult as it sounds. I made 2 holes as I saw this on some other builders sites.

(don't do this, Just drill 1. I'll explain later why)

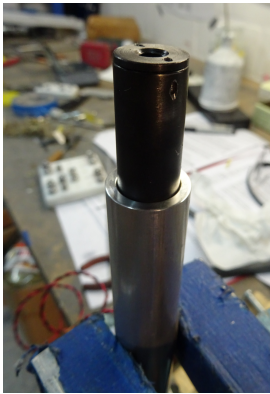
Another view from the side

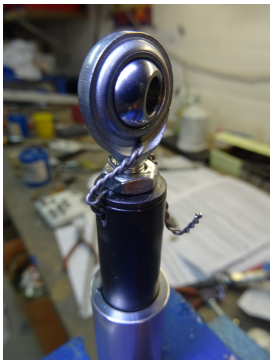
Then I drilled a hole in the middle of the rod end bearing and tried to safety wire the hole thing. This makes that the rod end bearing cannot turn.

Finally, I decided not to go this way. After talking to Vans support I learned that the actual thing you want to achieve is that the locking nut cannot turn. Both ways of securing (through the rod end or along the clevis) are ok for Vans but they did say that drilling a hole in the rod end bearing weakens that part. So I decided in the end only to go for one hole usage, installing a new rod end bearing and securing it like on the plans and in the SB.
