I had a good reason for that. Vans published a service bulletin ([SB-16-03-28](#)).

## 28/2/2020 - drill out inner aileron bracket - 2,5h

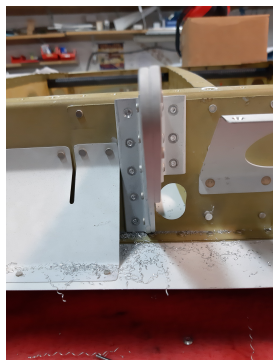
Here's a shot with all rivet heads removed.

Then I use a very small drill bit to drill the center hole. Then switch to #40 to the depth of the head. Then you pull out the head and

punch out the rivet with a pinpunch and hamer or sometimes I use the pinpunch to click it out.

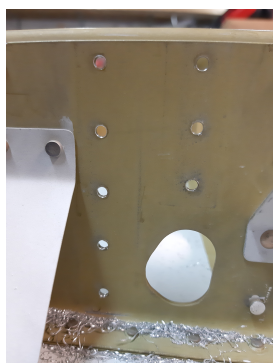
Tis image is the doulbler on the aft side. As you can see below, the holes came all out undamaged.

Then punched them out (like Vans suggested) backing up the rear spar with two tungsten bucking bars on each side of the hole. Then gently tapping them out.

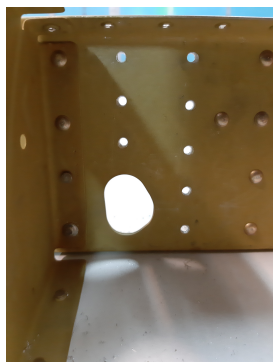
The next image is the inner side view of the rear spar. Here also totally ok.
