Category: 3.10. Baggage and seats area  
Published: Monday, 07 January 2019 19:36  
Hits: 1177

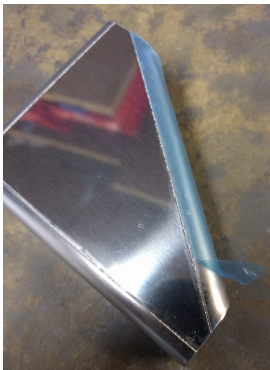
First I had to deburr and clean up the F-7114 gussets. They are treated roughly by the CNC machines at Vans and come marred with a lot of markings.

This is how it looked after removing the blue vinyl.

The markings are pretty deep. Fortunately you can scuff it out well on all sides using the die grinder and some rollo lock pads.

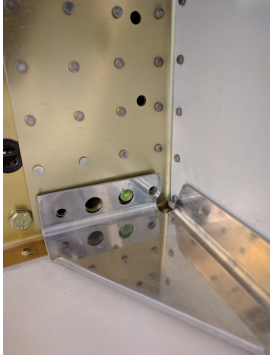
When both gussets were cleaned and treated with sandpaper, I tried to fit them in place. The passenger side looked pretty ok but on the pilot side, the holes really don't align.

I tried several times and nothing seemed to work. Ended up surfing the forums for solutions and found some entries that some guys have tried to close the bend angle on the outer flange. Tried it in different methods to reshape the part but nothing worked unless bending the flange in. The part is so beefy that it's just not possible to tighten the bend.

This is not going to work... I'll have to talk to Vans support again to see what I can do here.
