The goal of today was to cut the relief notches out of HS702. HS702 is a spar with a tab that needs to be bend at 6° to fit with the reinforcement spars HS710 and HS71.

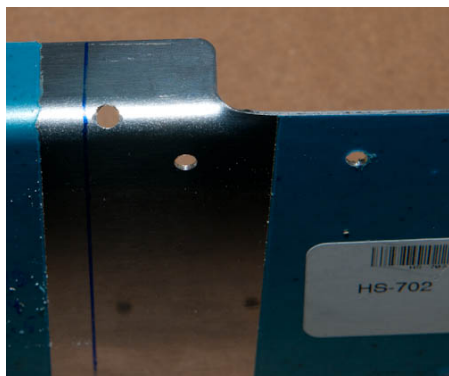
You start doing this by drawing the bend line at 5" 3/16 from the spar tab. Then drill a 1/8" hole at 1/8" from the bend line in the flange. This pilot hole will be enlarged to form the relief notch.

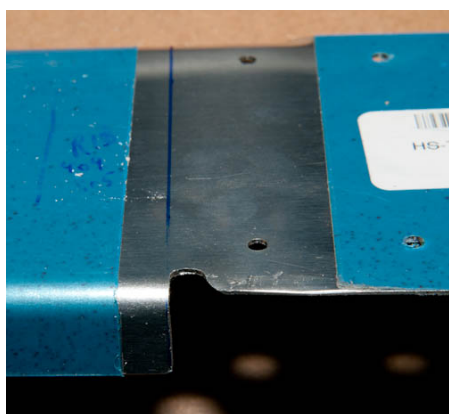
You take away the other material with a small round file. The plans call out for drilling with a unitbit to 1/4" but I found this to risky and preferred the manual work. They turned out quite nice in the end.

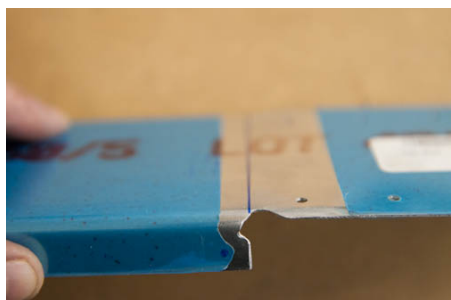
When I started working on the second piece, I found an unpleasant surprise underneath the blue plastic. The snip I made yesterday late went too far. I cut to the right position on the bend line but the aluminum overstretched beyond the end of the cut leaving a small crack beyond the bend line. Auch... I fixed this by drilling a #40 drill on the end of the crack line and then curving the aluminum into the notch. Fortunately, I still respect all the minimum edge distances on all holes so it should not be a problem as this cut out is on the flange and not in the structural part of the spar. The bend line is still the complete original shape of the piece. To make sure, I have contacted Vans support to get confirmation.

*The relief notch in your HS-702 is a bit larger than normal, but usable. I would simply take the sharper corners out and make it more of a smooth continuous curve. This is done essentially to prevent stress rises and cracks from developing.*
