Category: 3.1. Firewall

Time to get back to some serious business. You may recall that some time back, I had some head scratching moments when I discovered that my engine mounts had insufficient edge distance on the steel engine mount brackets. (WD-602-L and WD-602-R).

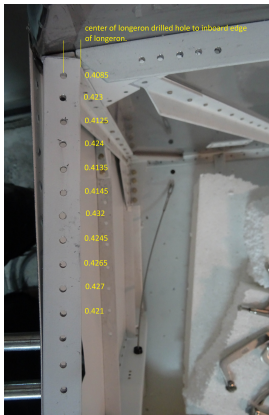
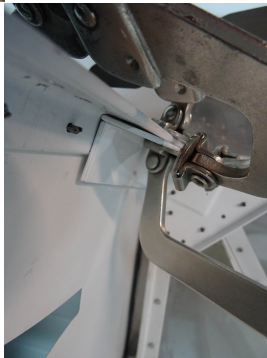
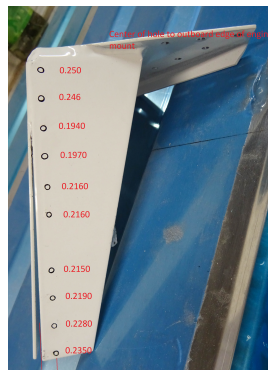
*In picture enginemount-3 I made picture of the mount and the distances measure from the outer (left) side of the leg to the assumed center of the rivet hole. 2D should give 0.250 edge distance but as you see, I'm on all holes too short. I started figuring out why this is and found out that the holes drilled in the longeron are all a little too much towards the inside of the longeron (outboard). I made measurements there as well and you see those on picture enginemount-1. (center of hole to inside edge of longeron) I'm not sure what I should do now. I could gently file away and round the upper tab of the WD-602 a bit, that might give me some thousands but even then, I'm not going to be*

reaching the 2D edge distance. Are these measurements ok to continue with ?

***Picture three with the estimated ED measurements looks perfectly acceptable to me. A steel part can accept shorter than standard 2D and still be structurally sound. Clamp, drill, deburr, rivet and build on!***

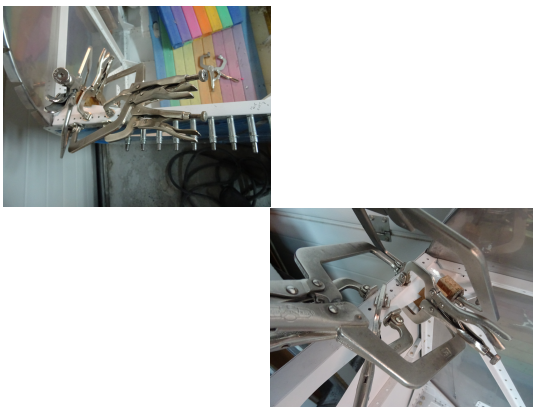
Well, you could say that I exagerated and that i clamped the hell out of it. Here's some pictures

I first filed away a slight bit of the outboard side of the upper tab so that it would nest even nicer in the longeron vertex. Then clecoed and started clamping to get the best possible nesting.

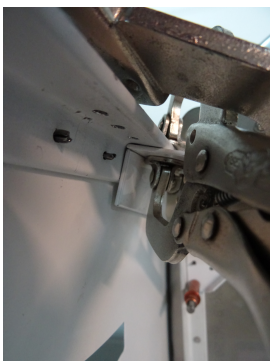
As you can see in the image below, this is what you are looking for.

I drilled all #30 and checked the inside, looks indeed much much better than the first time.

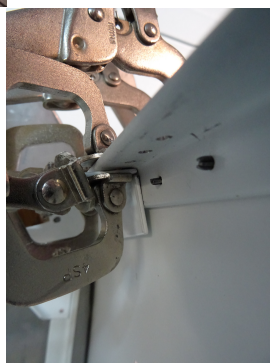
So I did the same on the passenger side and clamped away.

I removed both mounts and checked with the caliper for edge distance. Both edge distance reading were very good and even better than predicted on the mail to Sterling.
