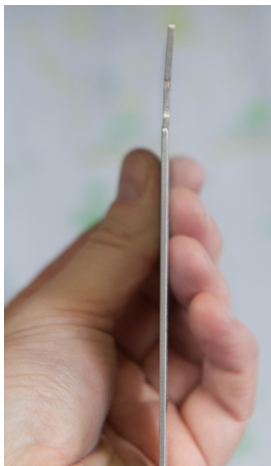
Here is the result of the bending. Not difficult, just measure with the calliper if you have the required height and match with the actual assembly to fine tune. Key here is that both sides rest flat on the surfaces where they will be rivetted.

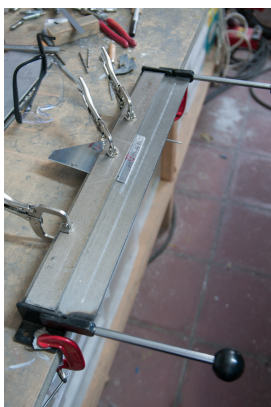
Another shot of the small bending brake

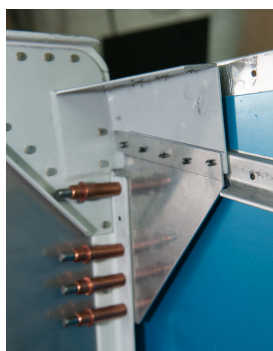
The next image shows nicely the reason for the bend. As you can see, in my part, the bend cause the gusset to fit nice and flat against the engine mount bracket. That's how it should be.

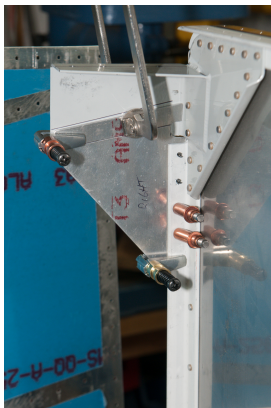
Repeated the same process on the other side. Just one more image to illustrate how I clamped and drilled the part. First I had 3 clamps on the top side to keep the height of the gusset stable while aligned with the firewall help line at 1/8. Then clamped with crock cleco the bottom side to the firewall angle and drilled the holes there. Clecoed and then drilled the top row in the engine mount bracket.
