## Aft fuselage matchdrilling - 14/09/2013

Category: 3.7. Tail Assembly

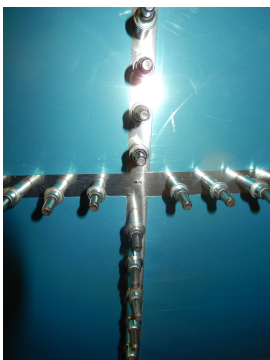
tada... a missdrilled hole...

~~Actually, and realised halfway through that I was not in the right~~  
It went just barely through the skin and not in the J-stiffener.

This is how my phantom hole looks like.

It's just next to the real pre punched hole and right at the intersection of fuselage skin, J-stiffener and F707 bulkhead.

Nevertheless, I drilled the real hole to full size and left it as is.

I think the holes are too close to each other to drill through the misdrilled hole and dimple and rivet both. The dimple just wouldn't work as they are too close.

I decided to call the mothership and ask them for advice how to deal with this.

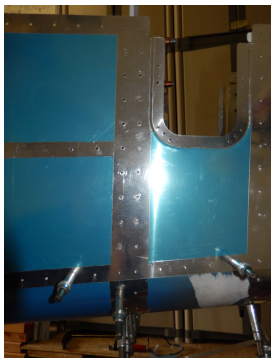
The holes don't align at all. Especially the double pre-punched line at F711 to skin is really bad.

The problem comes as a combined missfit of the F779 tail cone skin, the side skins and the F711 and F711 bulkheads.

First , I tried to drill one hole only in the tail cone skin and the j-stiffener. This at least allowed me to run a cleco through that aft skin.

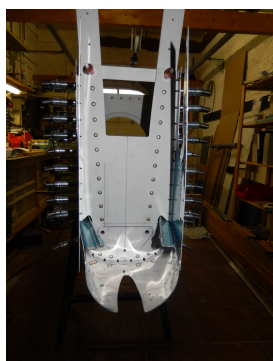
The match looked better after reforming the tailcone skin

Finally I took the whole thing appart again and start massaging the F779 tail cone skin hoping on a better fit.

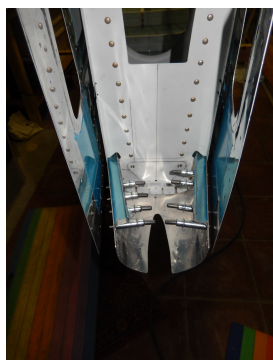
I decided to drill the J-stiffener first completely to the tail cone skin. That way, I can cleco the hole row together once the side skin comes on.

And Yes, finally, it came together better. But... it's still with a lot of pressure on the clecoes.

I decided to drill this as is now as I don't see how I can make this any better.

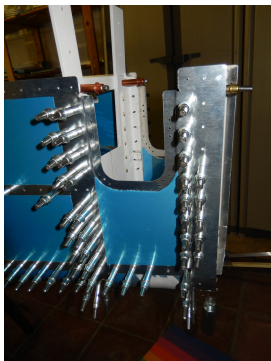
Then I matchdrilled the last row of rivets on the F712 bulkhead.

It would have been so much easier if Vans would have done the same on the F711 and leave the back side of the bulkhead flanges undrilled.
