## Problem fixing - 05/10/2013

Category: 3.7. Tail Assembly

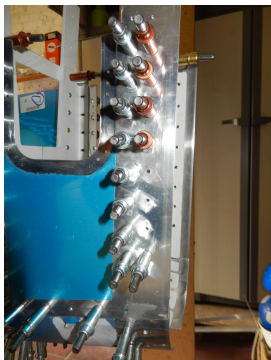
In the picture below, I started up-drilling the aft flange. First using #34 drill, then reaming with #30 reamer.

The result was really good. as you will see some pictures below.

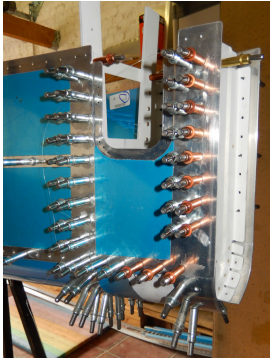
Here is an overview of all the up-drilled holes (bronze cleco's)
