Category: 3.7. Tail Assembly

## 18/10/2024 - Vertical stabilo rework / unhappy about rear fit. - 11h

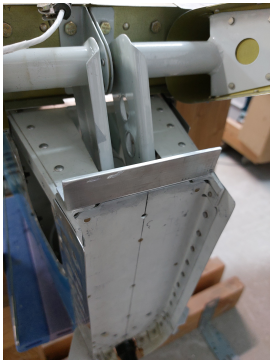
Top view of the same. The fasteners are not attached, this is just for alignment as the angle still needs to be primed.
