Category: 2.4. Main Wings

Time for some work on the aileron braces and fairings.

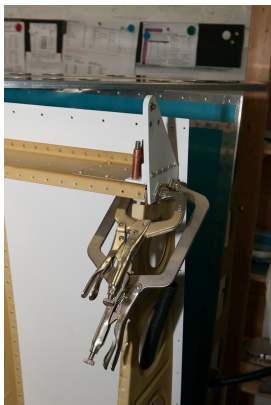
In the end, I did none of them. After some clamping and hand-forming, I could put the aileron bracket in place so that it stood up as good as straight. I clamped the rib against it and then drilled the #30 holes in for the AD4 rivets in the web of the outboard rib.

After drilling, it looks like this. Almost perpendicular. It makes no sense looking at a millimeter precision because anyway, the aileron will be installed enclosing this bracket and you will adjust by using washers between the aileron brackets (aileron side) so there is a nice and tight fit.

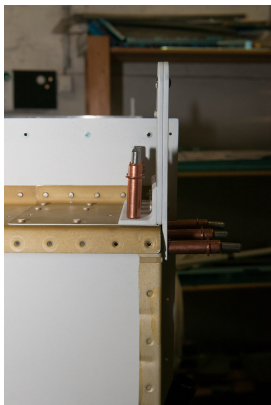
We started by shooting the outboard aileron bracket in place. We used the rivet gun but I found out that you can actually squeeze these so if you need to do this on your own project, use the squeezer here. I have a yoke with the nose slightly grinded down to the size of the die's head. It fits perfectly then.

On the flat AN426AD4, we used a flat die mounted on the c-frame extension bar and shot on this using the backrivet set. A bit of overkill as it can also be squeezed. But in the end, it worked and it's a new technique to remember if I ever have to rivet in tighter places.

The black in the picture on the rivet is not really something bad. It's just the aluminum making the white primer dirty. The bracket alignment after rivetting was still fine.

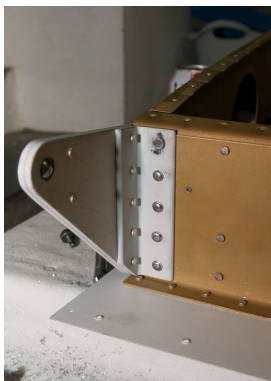
After that, we rivetted the outboard side of the aileron bracket using the rivet gun. Here again... you can actually use the squeezer on all of them by reaching through the lightning holes in the rib.

smilie on the side of the rivet that reached almost until the center of the manufactured head. There was no compromise on this, it had to come out again.

Additionally, on the two bottom rivets, the web did not fit nicely against the bracket. Could put a nail between. Not good...

The web of the rib on the inside was seriously deformed by the rivet being forced out of the hole. The sides of the hole were forced out. But even worse, there were 2 cracks in the holes.

I first squeezed the deformed hole with the pneumatic squeezer and two flat dies so the web of the rib would be more or less flat again with the aileron bracket. This worked quite fine.

Only option is to enlarged again to the next step to #12 for a AN6 rivet or a AN3 bolt.

Fortunately, this #12 size removed the crack from the hole in the web and made - after deburring - a nice smooth hole again.

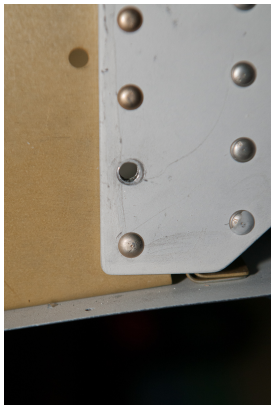
Other side on the aileron bracket side.

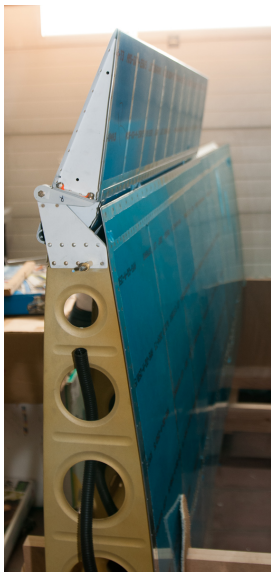
Nothing touches the main wing. The aileron moves freely in the brackets. Later on, I will have to install the aileron stop on the outboard aileron bracket. But this can only be done on final installation.

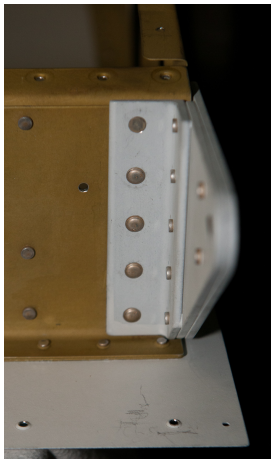
Could have squeezed also the middle wing aileron bracket but we shot them with the gun. The right side has some smilies in the surrounding

metal. Esthetically not so nice but acceptable

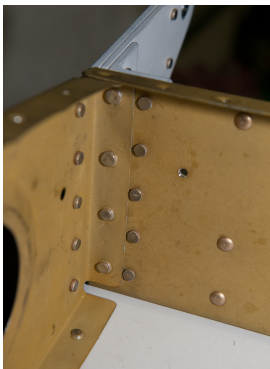
And rivet heads on the middle bracket

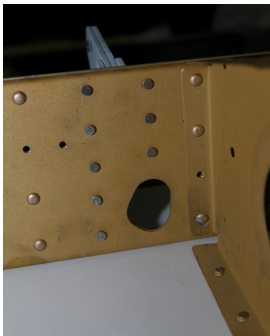
Installed the aileron fairing with the squeezer. This time installed the manufactured heads on the fairing (thin) side. The result looks much nicer.
