Started solving my fuelpump issues on the center cabin cover. Now that the feet on the fuel pump are #19 again, I need to cover the #12 holes in the center cabin cover with some doubler plates.

Category: 3.12. Systems

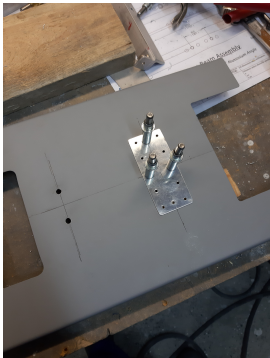
I made two doubler plates which I drilled on the cabin cover with for multiple AD3 rivets

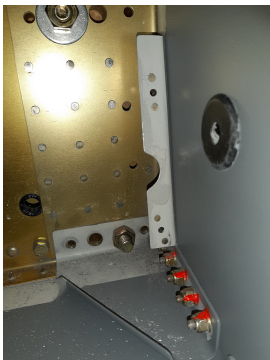
Next wanted to continue on the fuel lines and found out my outer support bracket for the fuel line cover didn't have the notch made yet for the grommet that goes in there and holds the fuel line. Quickly took care of that, sanded and fortunately has some wet primer paint left to touch it up with a brush.
