## 18/01/26 - Paint gap sanding - 4h

Category: 6.10 Sam James Cowling

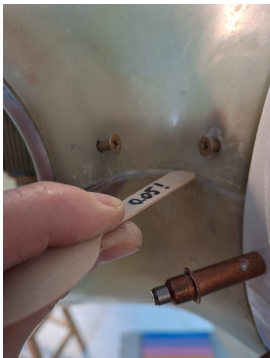
Here I'm checking the front gap between spinner and air inlet.

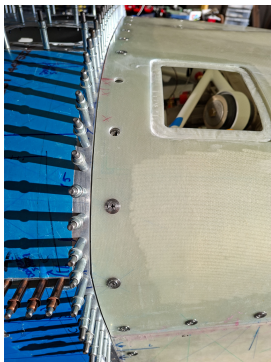
Top cowl gap showing. It needs some more fine tuning and that's work for the coming days.
