## Crotch seatbelt kit and more drilling - 28/12/2013

Category: 3.8. Center Fuselage

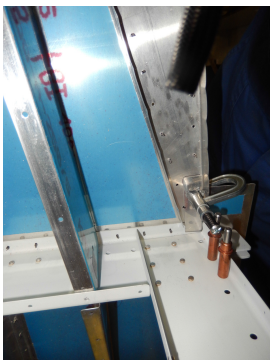
Then drilled the small F623A-FWD attach straps to the F623-L and R corner ribs.

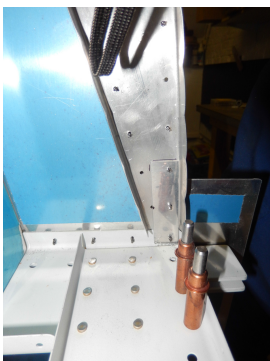
Clamped them in place and drilled.

One rivet is a bit in the way so I'll have to cutout a small portion

later. This is normal, every builder has to do this as the measurements on the plans are too wide.

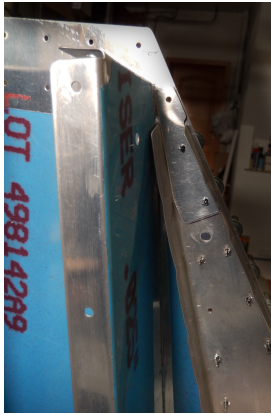
Next I positioned my original F623A-AFT attach straps and found that the edge distance would be very small. I decided to make some new attach straps that would fit the assembly more. It looks kind of funky but the edge distance is much better now.
