Category: 2.8. Closing skins

## 18/04/2020 - Rivetting, pitot line and some touchup work - 3h

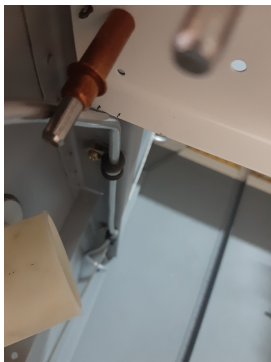
I also noticed that in the front of the cabin, the vent lines were touching the F7105-B outboard sub panels. Should have bend them a bit lower when I made them. Good reminder for the next RV7 I will build (yeah right...)

I marked the places that interfere and carefully filed a bit away.

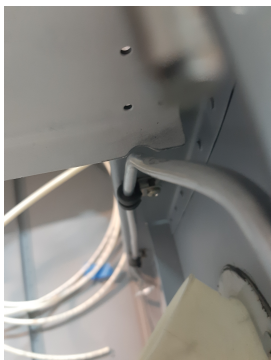
Same issue on the other side. I deburred it all and reinstalled. Looks very good now. Enough spacing not to cause any touching by vibration.

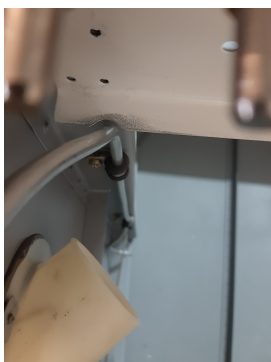
Same other side. The amount taken away is really small. Will touch it up with some primer.

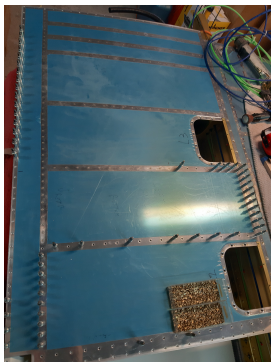
Continued some more rivetting as well. This is about as far as I can go in L shape before the outer wing skin must go on as well. So time for a final inspection of the outboard section of the wing.
