Category: 3.11. Empennage mounting

## 01/09/2019 - Rivet vertical stab attach plate - 2h30

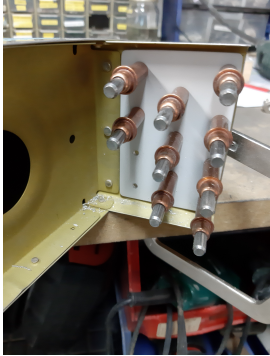
More opportunities for rivetting after priming. Next up is the vertical stabilizer attach plate. This was drilled earlier and is now ready for rivetting.

The crucial part here was ensuring edge distance on the bottom line of rivets (right in the picture).

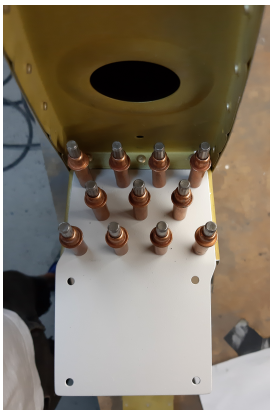
Clecoed it all together and started rivetting. Most of these could be squeezed

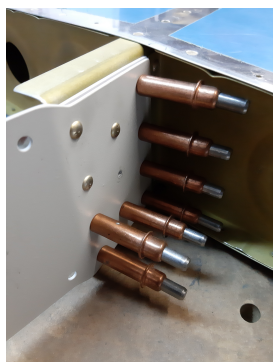
The first ones in place.

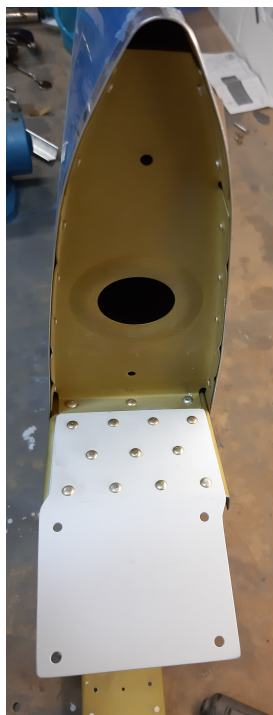
And a bit later, all are done.

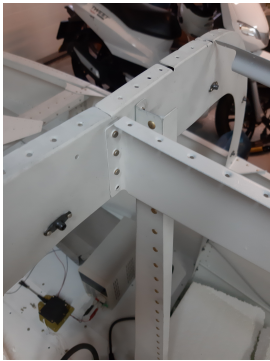
I found some more rivets missing in the bulkhead connections.

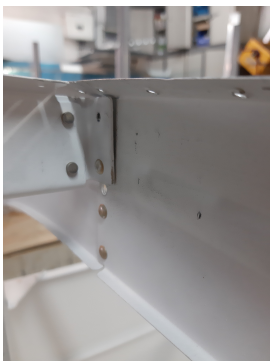
And on the other hand, I found that this is going to be a problem when rivetting the top fuselage skins.

There is no way to rivet the top rivets in the intersection so had to drill out the two rivets in the top in order to be able to slightly move the F787 stiffener. It's gonna be real fun having to rejoin those from the inside once the top skin is on, but there 's no other way to it.
