Category: 4.5. Fairings

Continuing the work of installing the top fairings on elevator and rudder. As I drilled the bottom holes yesterday, it's time now to further fine tune the alignment of the VS elevator tip and the rudder. There is not much you can do on the rudder fairing but the VS tip is still kind of flexing right now.

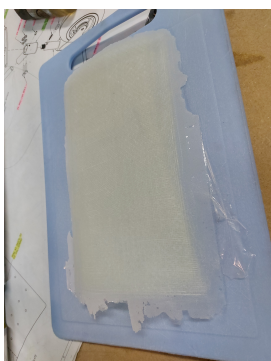
I'm happy with this and will make the rear side epoxy part. This also needs some curve so I will re-use the bucket technique as I did on the HS tips. Once cured, it looked like this:

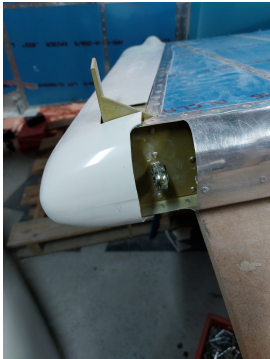
One other thing I noticed is that the front of the horn has the lip of the fairing sticking out a bit and pointing outwards. Reason for this

is the edge of the aluminum underneath which prevents the epoxy from laying nicely against the bottom of the rudder.

Epoxy becomes more flexible when heated and hardens again after cooling.

To fix this issue, I used the heat gun to heat up the epoxy and used my tungsten bucking bar to press the lip against the rudder bottom. The reason for using the bucking bar is quite obvious: the epoxy gets freaking hot and you won't be able to touch it with your fingers. The bucking bar gives a nice flat surface to press the epoxy against the rudder. Once cooled down it stayed in the right position and the fit looks much better now.

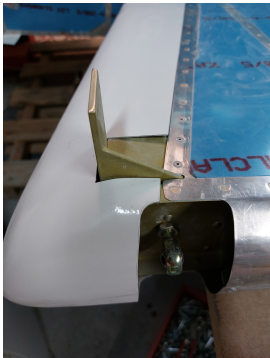
The image below is after cooling. As you can see the lip is now nicely against the aluminum edge below without any stress. This will making the installation of the #6 screw easy.
