Category: 4.5. Fairings

Final steps of working on the vertical stabilisor tip. All epoxy has cured and I have polished and sanded the edges of the new epoxy rear cover.

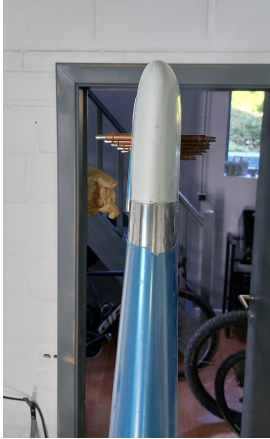
The shape looks very good. The rudder had a little swing when taking the picture but when in line, the alignment between rudder and VS tip is as required.

The gap between the rudder and tip is straight and sufficient for the 1/8" tot 3/16" minimum gap as prescribed in the plans. There is no specific value for the VS tip but I assume it follow the same gap specification as is given between the HS tip and elevator as indicated on DWG 3.

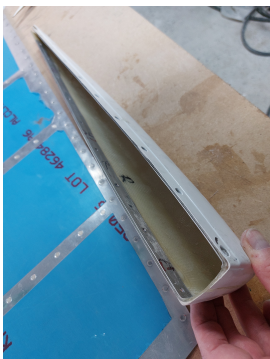
Next I verified the inside of the R-909 rudder tip. As with the elevators, I installed an aluminum reinforcement strip on both sides to facilitate and strengthen the grip of the pop rivet.

I first re-ensured the AN365-1032 nuts on the counterweight were properly thight and then final installed the rudder tip with CS4-4 pop rivets.

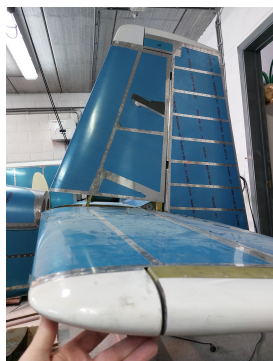
Re-attached the rudder and admired the result.

This looks so damned cool. Finally it starts to look like a finished airplane tail.

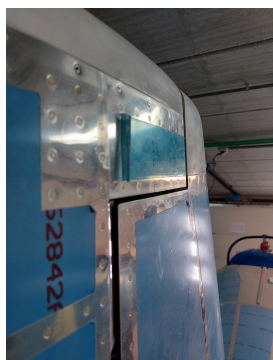
Some more alignment shots.

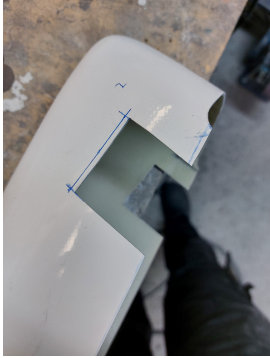
Then returned to the R-911 rudder bottom fairing. There is some more cutting and tweaking to do here in order to get a snug fit. I had to remove some more of the horn cut out.

Having to remove more had everything to do with the spacing that you want between the rudder bottom fairing and the tail spring wheel. Without this additional cut, the rudder fairing was almost touching

the tail spring. On a hard landing this would shatter the rudder fairing and potentially damage the rudder.

I wanted at least a 1/2" clearance between the rudder fairing and the tailspring to be on the safe side.

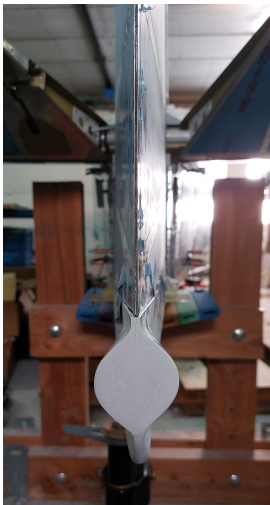
I reinstalled the fairing after cutting and checked the alignment and straightness of the fairing in relation to the rudder aft line. This looks fine for me.

The clearance is good. All the cutting has left a bit of a gap in front of the rudder horn but I will close that with some lay-up of fibre once the R-911 rudder bottom is drilled to the R-918 bottom attach strip.

I also drilled a 1/4" drainage hole at the low point (forward of the

rudder fairing) to allow water to drain out of the rudder bottom. The front of the rudder is open where the rod end bearings attach and the rudder bottom fairing acts as a bucket that will collect all the water coming in if there would not be a draining hole. Remember that you might end up in rain and water can quickly pile up in the rudder bottom as it runs down the rudder front spar.
