Category: 4.5. Fairings

Continuing redrilling the pilot side inner wheel pant connection 8R8 screws.

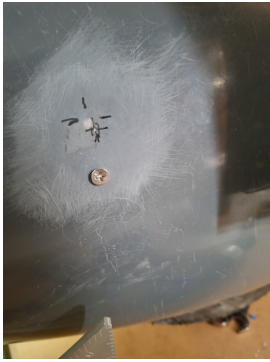
As you can see in the image below, the upper drilled hole did not come out even close to the bracket underneath once the bracket is pulled towards the wheel pant.

I re-drilled the front size top screw and this one seemed to come out nice now. I will use the same "offset technique" from the first hole to locate the second.

First drill a small hole and size up.

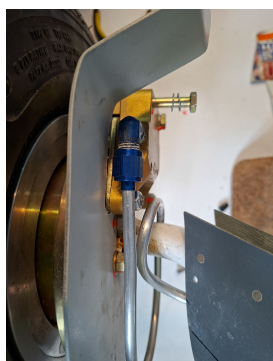
When installing the rear wheel pant on the passenger side, I noticed the inner bracket legs were seriously out of line and would need some bending of the thick aluminum.

I did not succeed this on a first attempt and decided to take the whole wheel assembly apart to do this bending on my workbench.

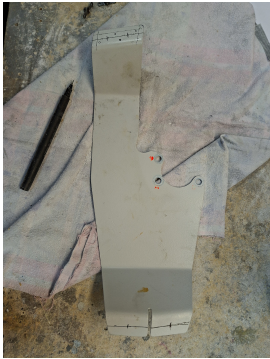
The advantage of this is that the installation of the nutplates will be easier to do this way. But the whole disassembly and assembly of the wheel again is some additional work.
