## 23/02/2017 Countersink missing #30s on forward longeron - 1h

Category: 3.9. Forward and Center fuselage

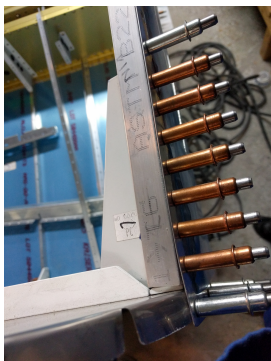
And here is the reassembled longeron to firewall mount after countersinking. Nice and snugg.

Well guess what... I found out today why my countersinks were so bad. There were no countersinks at all ! I just forgot those while doing the numerous #40 holes on the longerons. Need more convincing why you need to reassemble once more before priming ? don't think so.

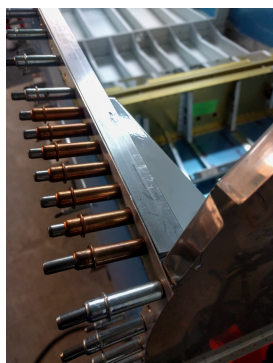
And same on the passenger side.

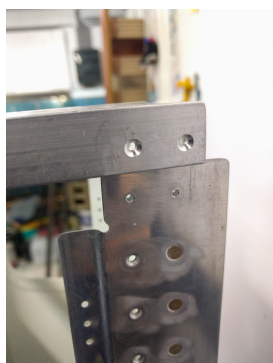
This is one I knew about. I countersunk the longeron at the aft end but knew I hadn't dimpled the side skin there yet.

The reason why it wasn't dimpled yet is the problem shown in the picture below.

The F712 tabs interfere with dimpling and leave a very tinys space, just enough to slide the longeron in between.

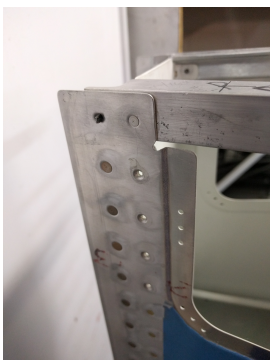
And here is the result with both done. The black thingy in the last hole you see is a cleco from the other side to keep it all close together while doing the dimple. The right side shows how nice my dimple sits in the longeron.

I had to use a G-yoke on the hole with the rivet to reach around the longeron.

So I decided that I could use the countersink hole in the longeron as female die and squeeze the dimple in with the longeron in it's final position.

I used the squeeze with a C-yoke for the last hole and put the male dice at the pusher and a flat rivetting die on the top. The hole thing with longeron, F712 tab and skin is thick enough so the male die will not push into the flat rivet die although I had to completely close it to get the desired result.

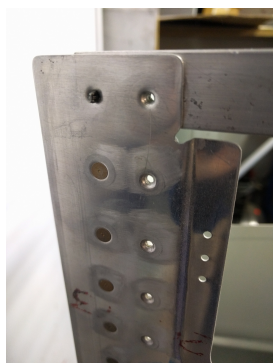
same without the rivet

Longeron fully ready now, up to the next task on the checklist.
