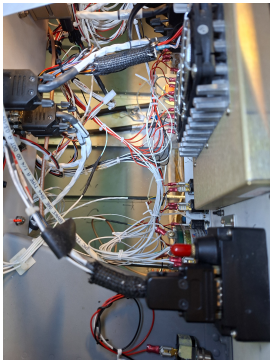
The area behind the switches and skyview.

The main exercise here is to make sure the wires are organised in bundles and that they are not visible from within the seat.

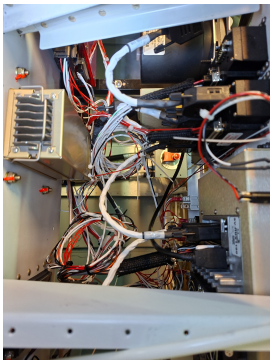
And the area behind the skyview modules and analog instruments in the center of the panel.
