Category: 6.10 Sam James Cowling

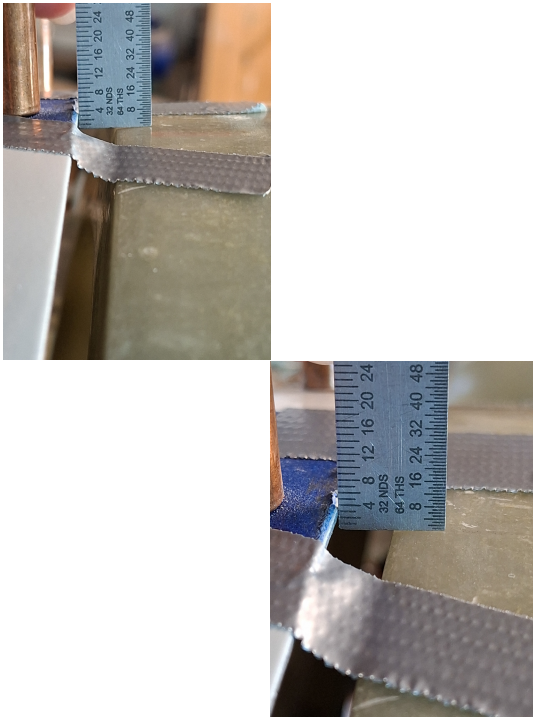
I took the steel ruler out and measured from the angled step on the front of the top cowl to the spinner and get to 4/32" or 1/8". Even if the hole things moves down a bit when attaching the final skybolt fasteners in the 15/32" holes on the side I still won't go over 1/4" so that's safe as well.

I decided to go with 1/8" step. It's the closest to what I already have now and only requires minor sanding on the horizontal sides. "IF" my engine would sag more than 1/8", the small extra step would be small. If I don't foresee anything and it moves down 1/4" the step would be considerable. So I'm going for the compromise solution and hope for the middle value of 1/8" which is what most builders do.

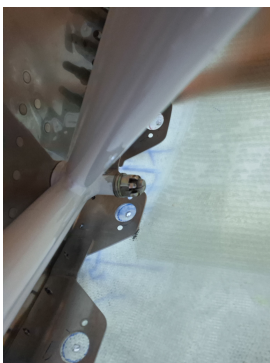
The image below is inverted, taken from the bottom up. What you see here are the traced holes in the top cowling read firewall line. I took out every other cleco adapter and took a sharpie to mark the location of the bracket holes. This will be the visual clues to updrill with a unibit #1 up to 15/32", making sure the hole stays centered in the marked circle. Moving the hole slightly using a unibit in epoxy is fairly easy and there are multiple steps down the road up to 15/32". This updrilling seemed critical and difficult but it was actually a walk in the parc

Then placed the adapters back in the just traced holes, clecoed and did the same on the newly freed hole locations. After taking the top cowling off, you now have all drill traces.

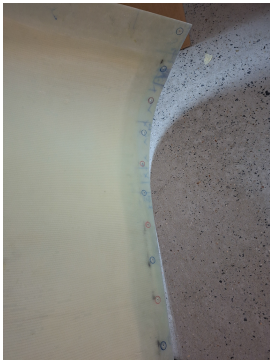
I am quite unhappy of the shape of the cowl on the passenger side near the down-bend line. This is the location where the cowling is extra reinforced because of the oil door location. In this 7 to 8 inch, the epoxy is much thicker and was sticking up over the fuselage skin. I decided to place an additional 0.032 shim underneath this length which is about 10" in total.

This will lower the top cowl enough to be level with the fuselage skin.

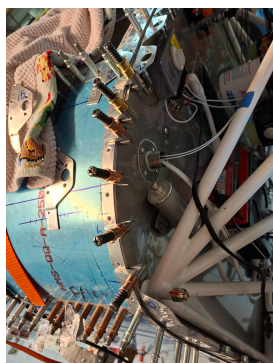
After reinstalling the brackets, the fit was near perfect. Glad I took the time to get this right. I did have to retrace the circles on the lower holes as this extra shimming did move all holes down the road down a bit. Not much, but enough to get alignment problems later on if I didn't pay attention to it now.

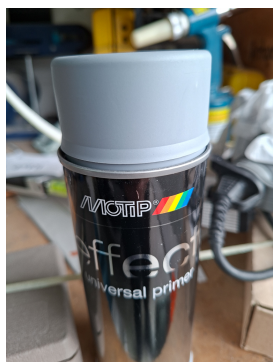
Then I took off all brackets and primed them. I am using a spray can primer in gray and sprayed 8 layers of primer paint on the brackets.

The primer is a good choice. It dries pretty quickly and after 4 hours of waiting I could invert the parts and also spray the back side on the same day.
