Category: 3.11. Empennage mounting

## 23/8/2019 - rudder stops and pushrod fitting - 4h30

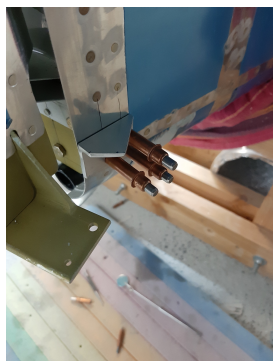
After making the rudder stops, I drilled them to the end of the fuselage. The rudder stops make sure that the rudder can not bounce into the elevators which would destroy it's skin and have catastrophic consequences.

Measured according to plans and drilled them to the last bulkhead. It's more tricky then it looks.

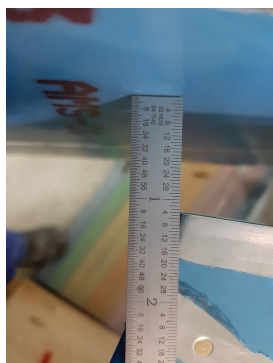
Then cross checked that the rudder is at max 35° degrees deflection. The alternate method given in the manual is making sure that the distance between the rudder skin and elevator trailing edge is at least 1 inch and 1/8.

*"The proper 350 degree swing is attained when the clearance between the inboard trailing edge of the elevator skin and rudder skin is 1 1/8" when measured perpendicular to the rudder skin with the elevator in the neutral position. File the rudder stops if necessary to achieve this dimension."*

Here's the picture of the measurement. Exactly 1" 1/8.

Vans support replied in one of my mails that it should definitely not be less than 1 inch. If the spacing is still too large, grind down the rudderstop horizontal surface trailing edge until the deflection is at the right distance.

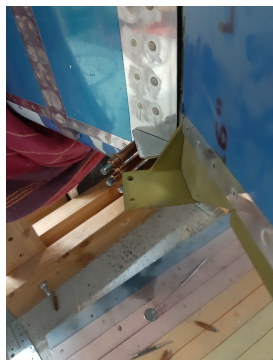
Did the same thing on the other side.

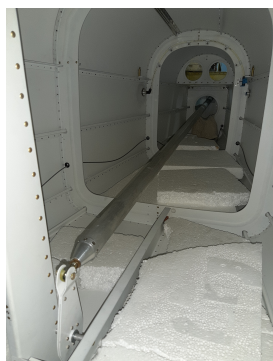
The idea here is to make sure that the rod end bearings on the pushrod are installed and extended in such a way that with the elevators in neutral position, the F635 elevator bellcrank is in a full vertical position.

You achieve this by shortening or extending the rod end bearings on the VA-101 threaded rod end. The manual also states that you have to ensure that on both ends, at least half of the threads of the rod end bearings are engaged in the VA-101.

I had some time left and test fitted the elevator pushrod in the tail section of the fuselage.

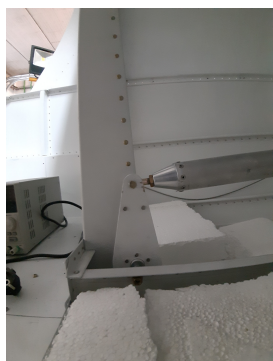
Here's a look at the elevator bellcrank F635 assembly. (the pivoting triangular shape in the picture). On the other end (not visible), the shorter pushrod will connect the bellcrank to the control column. The F635 needs to be perpendicular but this actually not as simple as it sounds since the whole fuselage tail section is tilted, including the F-729B angle on the bellcrank rib.

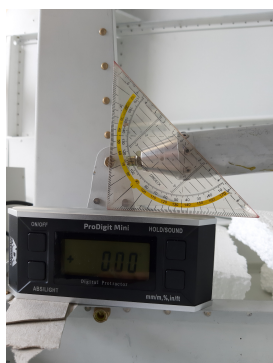
Finally I came up with this construction where I put the inclinometer out and set it to 0 degrees on the angle and then measured perpendicular state using a geo triangle. Looks pretty good.

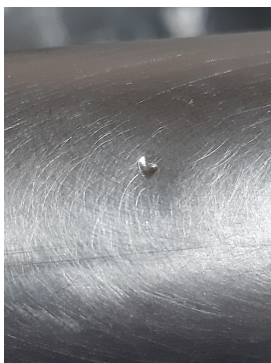
I found this little dent in te elevator pushrod. No idea where this came from. Looks like something bumped into it or fell on it. Fortunately it's only on the surface and won't harm the strength. Sanded it smooth and will be covered when priming.
