Category: 3.9b. Top Fuselage

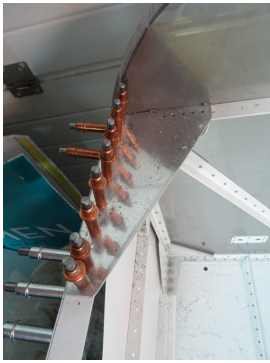
Bottom view... Damn... those holes in the engine mount look really close to the edge...

This is where I realised that I would have needed also to clamp the engine mount bracket top flange and pull it inward against the longeron.

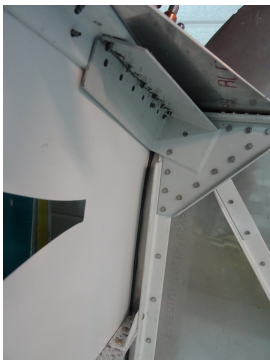
I'll have to inspect that more closely and cold sweat breaks out...
