Category: 3.9b. Top Fuselage

## 28/07/2018 - F707B Angle clip and fitting to fuselage - 1h

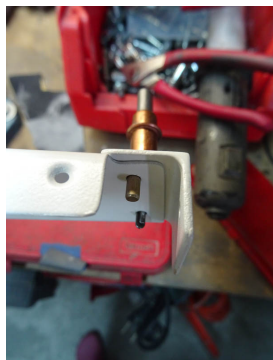
Rivettted the F-707B angle clip to the f-787 stiffener web. These can be rivetted together but it's not allowed yet to rivet the stiffener web to the F-707 bulkhead. The top rivets would interfere with rivetting the top skin to the bulkhead flange so don't rivet this yet.

Easy set with the pneumatic squeezer in no time.
