## 28/11/2019 - Control column fitting - 4H

Category: 3.12. Systems

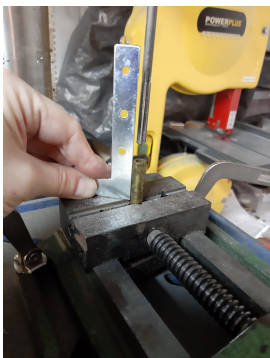
I decided to ream to 1/4" using the bench drill. I have a clamp that holds with some jaws that hold the bushing nicely at 90°. To ensure this, I used a straight angle to verify.

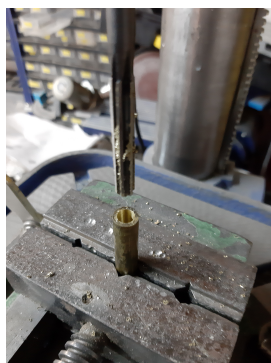
Then gently sent the reamer through with plenty of boelube lubricant.

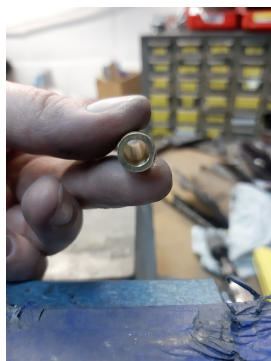
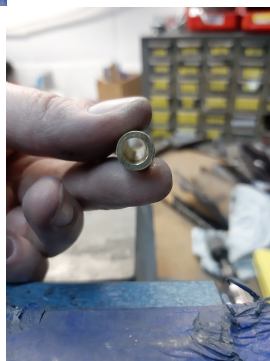
The result is not bad, but it's certainly not perfect. On the top side where you enter the material it's dead center. On the other end it tried to find it's way down and was little off center.

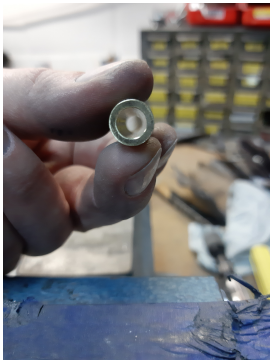
The other one was even more off. I'm assuming this is not going to be an issue. There's plenty of material left to support the AN4 bolt. In the end the bolt will take the load and the busing serves as a support for rotation.

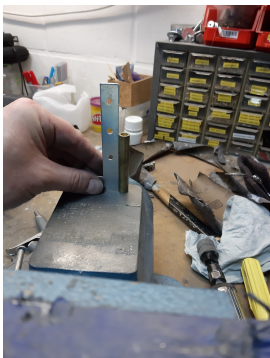
Instead I started using the good old sandpaper and bench drill technique to gently shorten it. This ensures absolutely perfect perpendicular bottom and top.

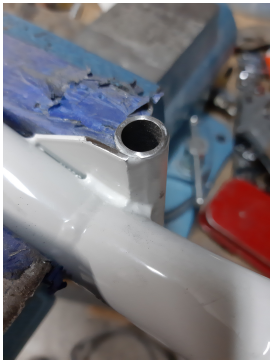
After evaluating this a bit, found out that actually the sides of the WD-611 and WD-612 are welded and are a bit wider than the actual place where the bushing runs through.

Started grinding it down a bit using a key file. Be gentle and make sure you don't change the shape of the circular tube where the bushing runs through.

they annoying part in this is that you take away the powder coating of the steel and thus you must prime that exposed metal again... did that and now it's paint curing time again.
