## 18/01/26 - Exhaust interference with cowl - 1h

Category: 6.3 Vetterman Exhaust System

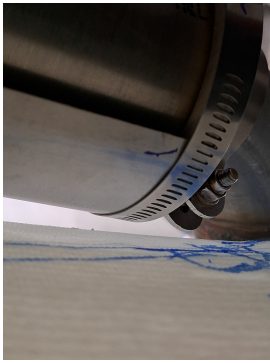
A little further down the pipe, the exhaust has a joggle that bends it inside towards the center of the fuselage exit point. The spacing between the cowl and bend is close but would be acceptable. I don't have slip joints and my exhaust is very rigid.

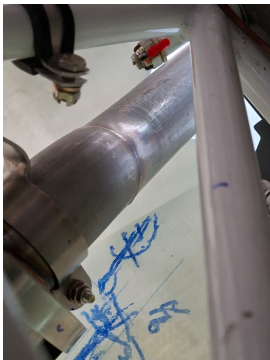
On the passenger side, the story is completely different.

As you can see in the image below, the joggle bend is very close to the cowl. The muffler has nothing to do with this, even without the muffler I would face this issue.

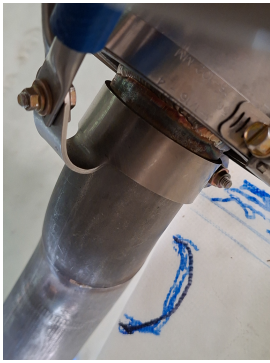
It seems like the angle on the exhaust is slightly different than on the other side. This image shows it from the top.
