Category: 4.5. Fairings

More cutting on the pilot side bottom wheel pant. You want to go slow not to cut away too much at once.

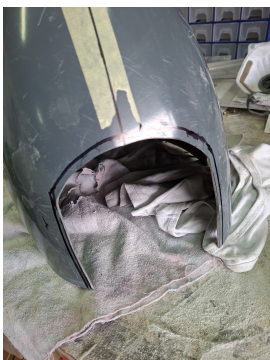
Here is a picture of the clearance on the inside. I reduced the tyre pressure to 20psi and now got about 1/2". I will start with this gap and see how things go when the airplane is back on it's legs and pressure is applied to the tyre at 20 psi.

The way I measure the gap is by placing a 1/2" aluminum scrap piece between the tyre and the wheel pant.

expect to cut back quite a bit
