Another rivetting session on the forward fuselage.

This time we knocked in the rest of the F705, baggage bulkheads F-722 and F-724s an both sides and most of the joint of aft and center fuselage.

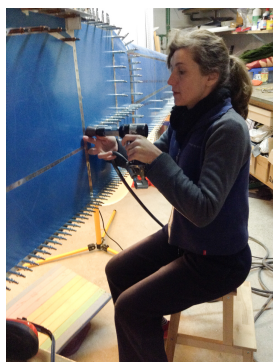
The joint of the forward and aft fuselage are really nice and thight.

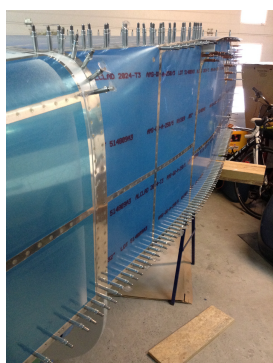
view of the belly. Also here very nice joint.
