## 15/07/2018 - Setting some missing rivets - 2h

Category: 3.9b. Top Fuselage

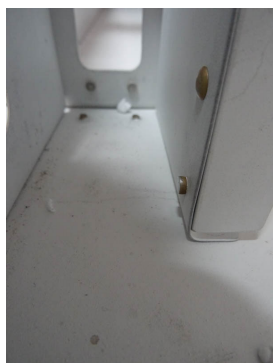
First did some rivets in the top of the last bulkhead and then noticed this open hole underneath the stiffener. I had tried to set this rivet before and noticed that the hole was enlarged while drilling out.

I made a small doubler to solve this. It's so tight there that it's almost impossible to hold the little doubler while bucking so I used some masking tape to hold it.

Set the rivet and here's the result. Looks good.
