Category: 2.4. Main Wings

Various tasks completed.

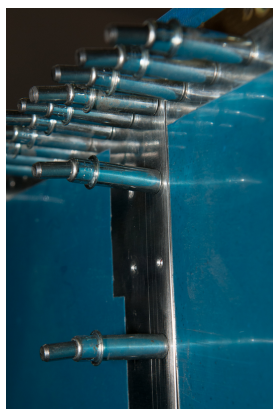
And the same setup in the other direction

Final job before priming is making the scarf joint where the skins overlap on the spar side of the wing. The outboard skin overlaps the inboard skin for little more then an inch. That means that you now have 2 times 0.032" material and this creates kind of a 'bump' in the middle of the skin which isn't that nice.

The idea here is to file away half of the size of the skin in an area about 2.5" wide in both directions. There is then a transition that goes gradually down in size toward 0.016". 2 times 0.016" is again 0.032"... get the point?
